GUIDING LIGHT MASTER REPORT 7-6.1

12411 Nectar Ct Houston, TX 77082

PROPERTY INSPECTION REPORT FORM

Abdullah Soomro	03/14/2024 9:00 am
Name of Client	Date of Inspection
12411 Nectar Ct, Houston, TX 77082	
Address of Inspected Property	
Maher Attieh	InterNACHI certified professional inspector
Name of Inspector	TREC License #
	26029
Name of Sponsor (if applicable)	TREC License #

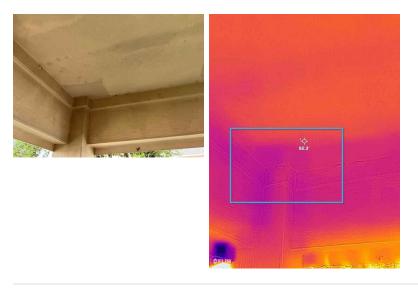
Ceiling structure showed signs of water intrusion, which could lead to more serious structural damage. Recommend a qualified contractor identify source or moisture and remedy.

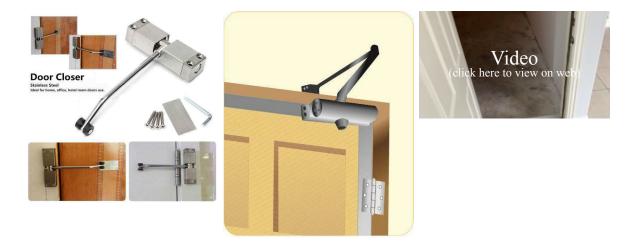
The door between the garage/attic and the interior of the house (garage/attic service entry door) should be equipped with an <u>auto-closer</u> device to prevent automobile fumes from entering the house. This is a good upgrade However the installations requirements are dependent of authorities having jurisdiction. This device is not a commonly found in our area of the state.

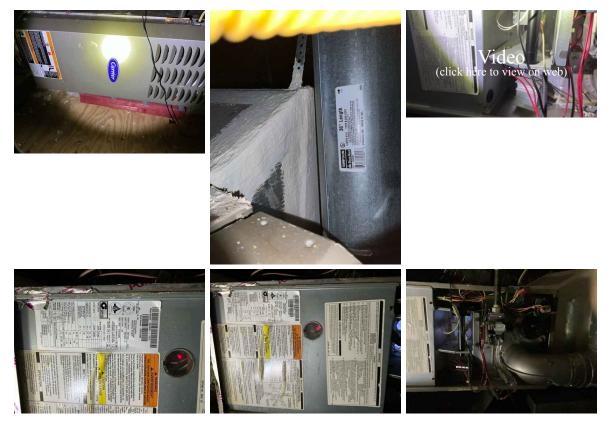
Brand : Carrier

It is recommended to have the heating unit cleaned and serviced by a licensed & qualified HVAC technician. The observations made to support the rendering of this opinion are listed but may not be limited to the following:
