MAHER'S WAY INSPECTIONS LLC

GUIDING LIGHT MASTER REPORT 7-6.1

14811 W Bend Dr  
Houston, TX 77082

# PROPERTY INSPECTION REPORT FORM

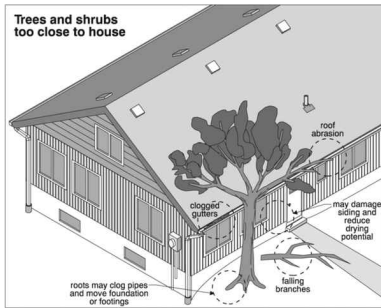
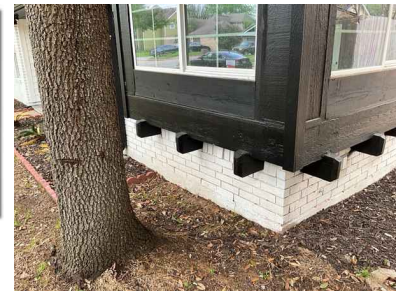
**2: Foundation repair noted**

Tree(s) in close proximity of the foundation was observed. Client should consider the installation of a root barrier to reduce the possibility of damage to the foundation from tree roots and moisture removal, or have the trees taken down so that they do not damage the property over time.

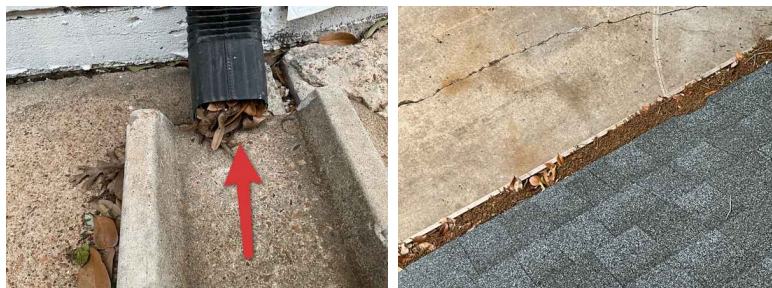
**3: Gutters - Downspout Terminating Next To The Structure**

There were one or more downspout drain tube(s) present that was/were discharging within 3-5 feet of the foundation of the structure. Current standards require downspouts to be diverted at least 3-5 feet from the foundation of a structure to prevent the grounds surrounding the foundation from becoming saturated. Saturated grounds can cause erosion, uneven settlement and if applicable allow water / moisture to enter basement and/or crawl space areas. We recommend extending all downspouts at least 3-5 feet away from the home. At very least you should install splash blocks that channel water away from the foundation under each downspout termination to prevent erosion.

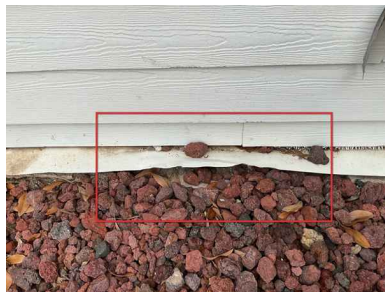
### 6: Gutters - Downspouts Are Damaged

There are downspouts that are damaged/missing at areas of the structure, these sections of downspouts should be replaced to allow proper flow of water out of the gutters.

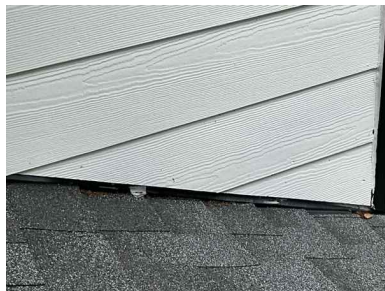
### 2: Flashing at side walls needed

The sidewalls of this home are in contact with roof covering material. The sidewalls are not properly flashed the flashing on the side wall should go under the shingles

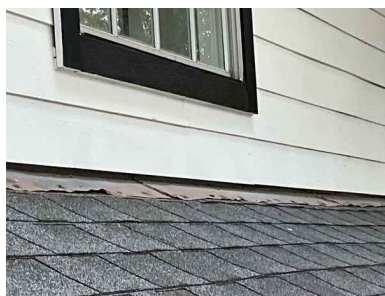
**4: Flashing rusted**

There is flashing on the roof that is rusted. We recommend that this flashing be cleaned and painted with a rust inhibiting paint to help prolong its useful life.

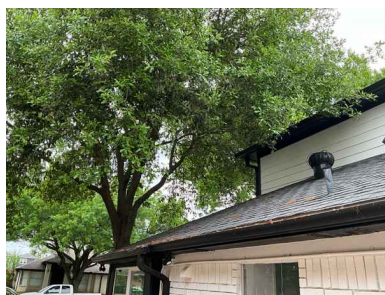
**5: Trees- Impinging Roof Line**

Tree branches impinging roof line can damage a roof even in a gentle breeze. Whenever a tree is in contact with the roof structure, we recommend trimming the tree or branches back aggressively.

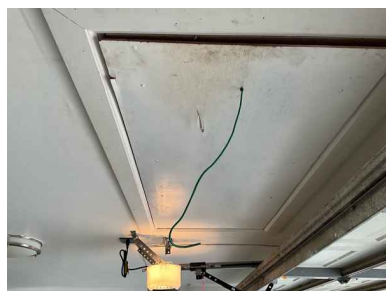
**2: Access- Attic ladder is not properly fire rated**

The stairway was not labeled as a fire-rated assembly. The Code addresses separation between the garage and attic, garage and dwelling and habitable areas and attic spaces, in terms of gypsum thickness, door thickness or 20-minute fire rated doors including attic stairs

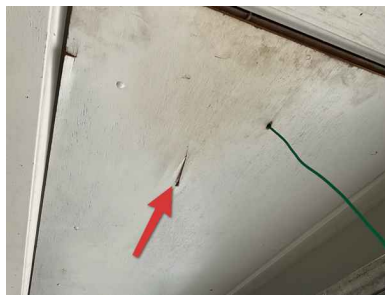
**4: Access- Attic ladder is in need of repair or replacement**

The attic ladder is in need of repair or replacement.

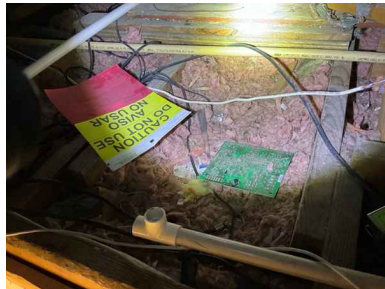
**5: Insulation- Damaged/Missing**

Insulation appears to have been pulled out or damaged. Recommend a qualified insulation contractor evaluate and repair.

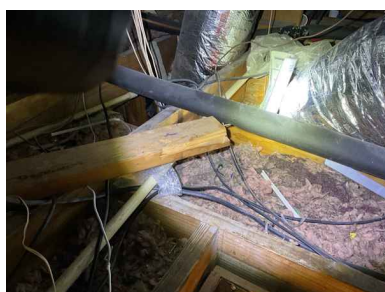
**7: Insulation- Insufficient**

Insulation depth was inadequate. Recommend a qualified attic insulation contractor install additional insulation.

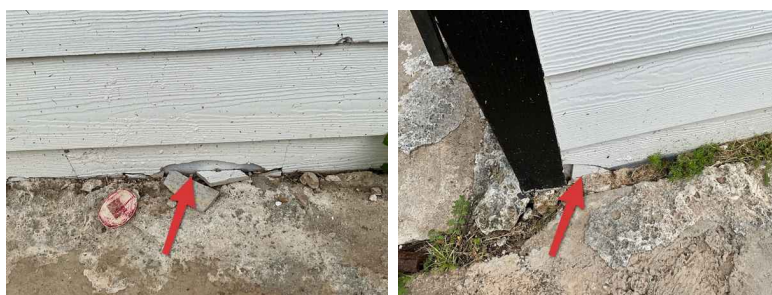
## 2: Fiber cement siding damaged

There are areas of the fiber cement siding and trim that are damaged and will need repair.

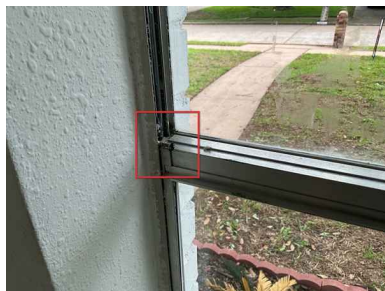
**2: Screws in windows**

There are windows throughout the home that have had a screw placed in the window to keep the window perminately locked. We recommend that these screws be removed to allow for secondary egress.

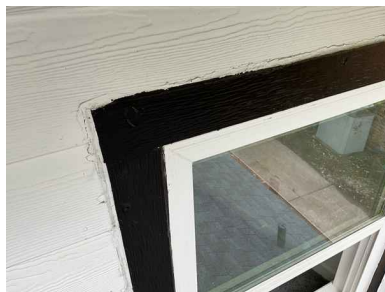
**4: Window caulking missing/damaged**

The caulking around the interior of the window is missing and/or damaged.

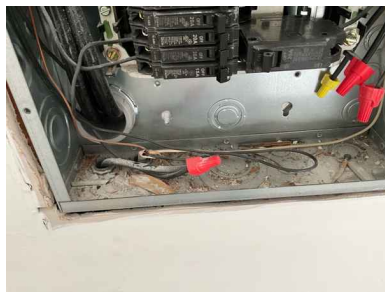
## 3: Debris in panel

There is debris in the panel that is in need of removal.

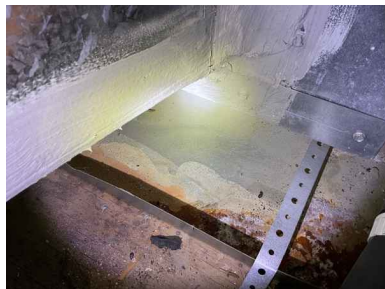
Rust/debris/water in the auxiliary condensate drain pan under the evaporator coils. This needs to be replaced.

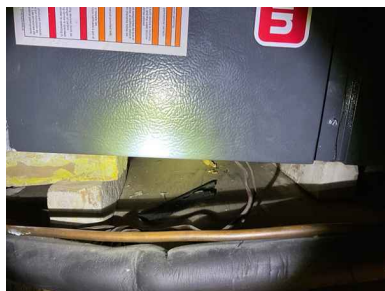
**2: The air handler in the attic is sitting on wooden blocks**

The air handler is sitting on wooden blocks in the auxiliary drain pan. We recommend that composite blocks be used for support for the air handler due to the possibility of condensation in the drain pan causing damage to the wood.

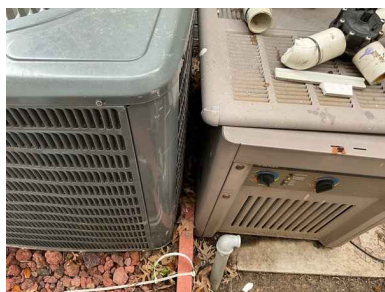
The outside condenser/coil does not appear to have proper clearance above the finish grade (ground). The outside unit should have a minimum of 3-inches of clearance above finish grade (ground). This condition should be corrected to help prevent damage to the unit.

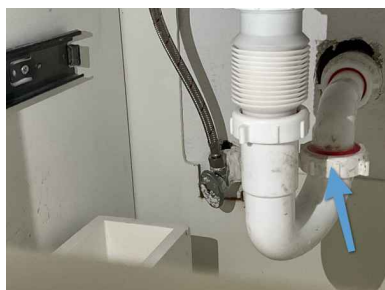
**1: Sink Drain Leaking**

There are one or more sink drains that are leaking at the time of inspection. This/these drains should be repaired to prevent damage to the cabinets or other materials that could become damaged due to contact with water from this drain leaking.

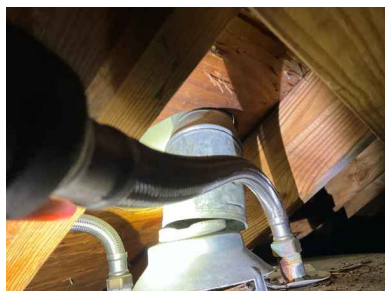
The scorching that is visible on the roof sheathing is a sign that the heat from the flue pipe is affecting the roof sheathing and should be repaired to prevent a potential fire hazard in the future.

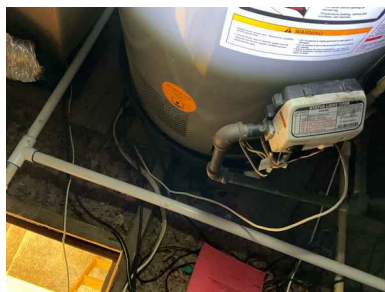
**4: Water heater pan is sitting on blocks**

This water heater pan is sitting on blocks. There is no real need for this

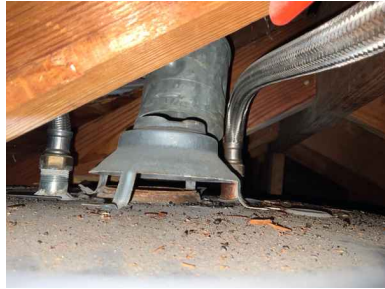
**5: Improperly installed flue**

The water heater flue was improperly installed. Gas flues should be a minimum of 3 feet above the ridgeline. Recommend having a licensed & qualified contractor evaluate and repair.

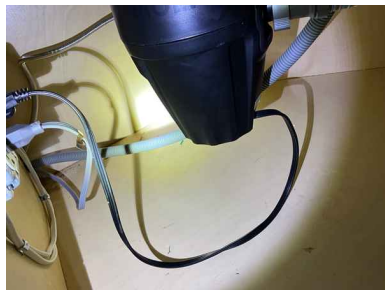
A "high loop" or "air gap" was not present for the dishwasher drain line at visible portions. A high loop or air gap prevents wastewater from siphoning back into the dishwasher during operation. The proper installation of the dishwasher drain line is recommended by a licensed plumber or other qualified person.
